LETTER OF TRANSMITTAL

Re: Principal: Craftsmen's Guild, Inc.
Bond No.: 9033691
Claim No.: AC 35414
License No.: 507159
Claimant: Ania Mitros and Seth LaForge
RCSI No.: 05833

ROEL Consulting Services Inc. (RCSI) has investigated the allegations contained in the claim filed by Ania Mitros and Seth LaForge. The Contract was dated July 22, 2009 and the contract amount was specified at \$152,799.00. The scope of work includes renovation of an existing single family dwelling. This includes demolition and removal of existing interior plaster, replace with new drywall, installation of new kitchen cabinets and appliances, wall finish and floor finish. Plumbing, electrical and HVAC were also included.

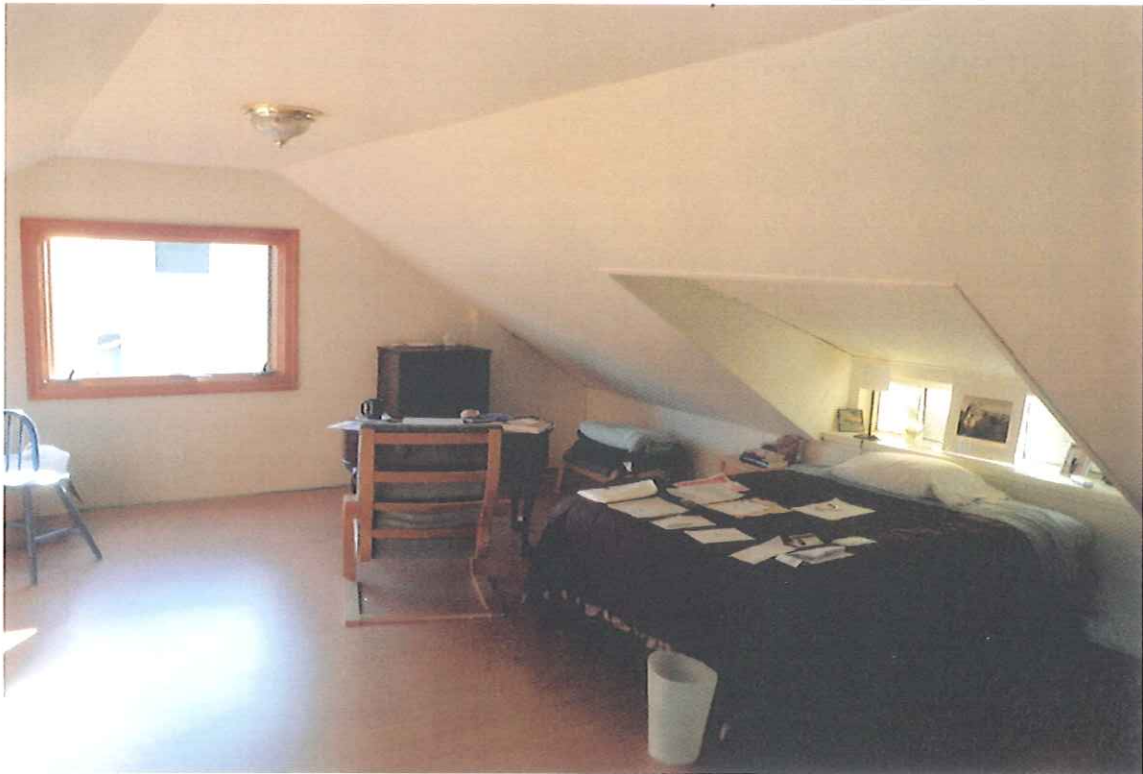
Date Taken: 10/19/2011 Photo ID: MGVD001 10-19-11 - 127
Condition in attic.

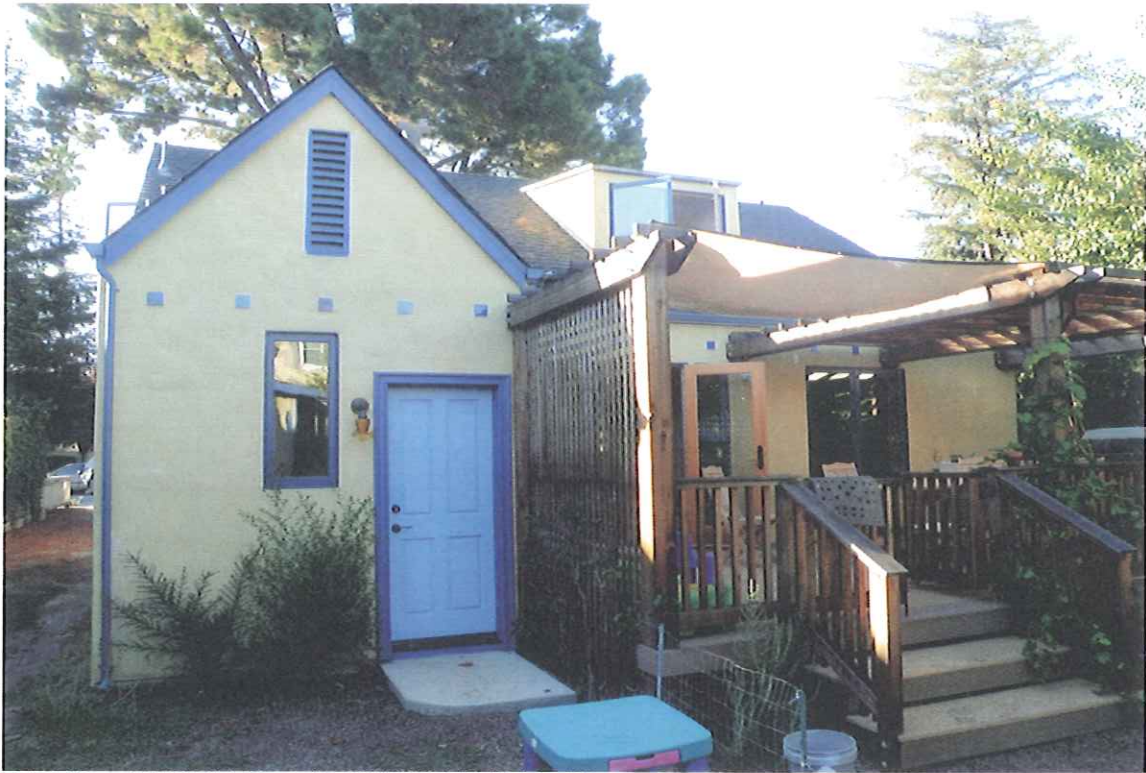
Date Taken: 10/19/2011 Photo ID: MGVD001 10-19-11 - 128
Rear overview.

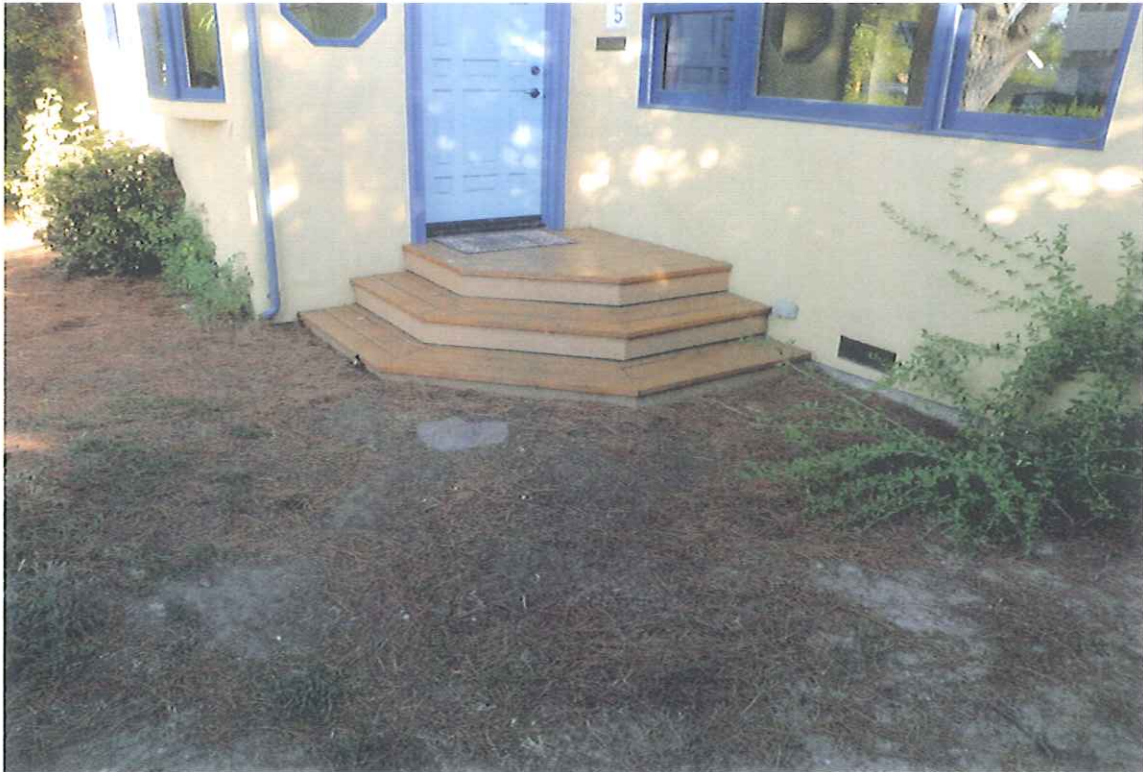
Date Taken: 10/19/2011 Photo ID: MGVD001 10-19-11 - 129
Yard and front porch.

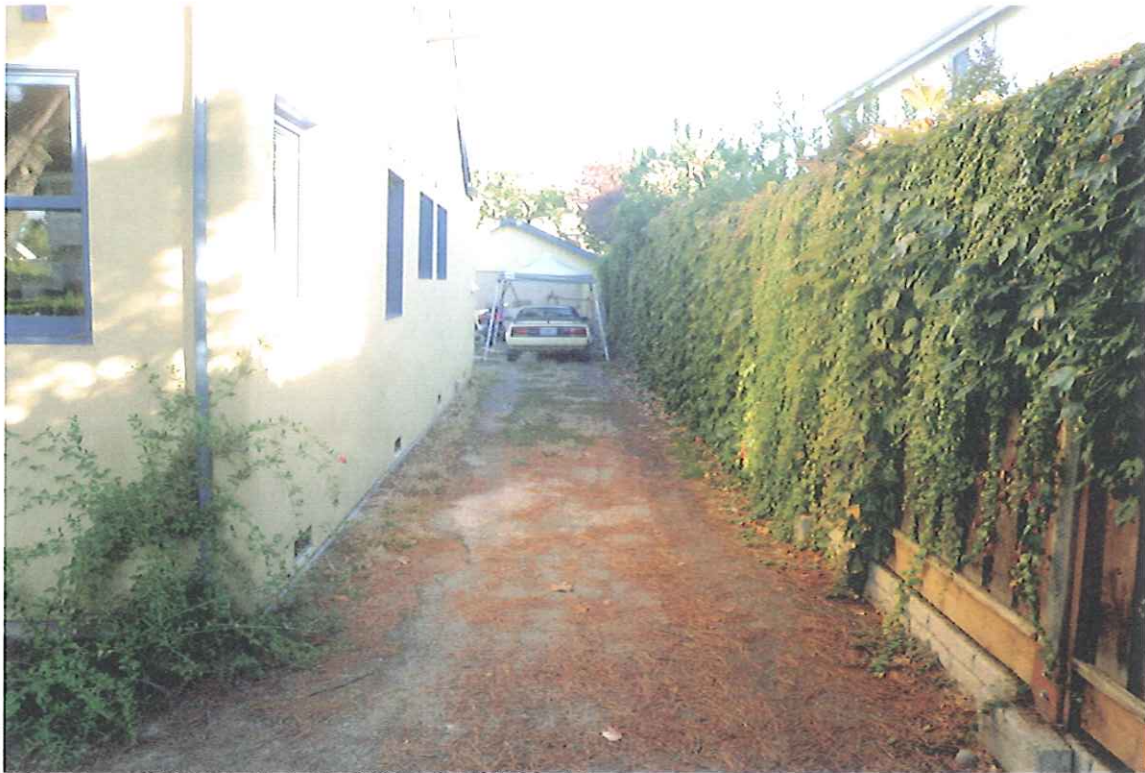
Date Taken: 10/19/2011 Photo ID: MGVD001 10-19-11 - 130
Condition at driveway.
